Hurricane Harvey

Clean Rivers Program Impact

Lessons Learned from Laboratory Flooding

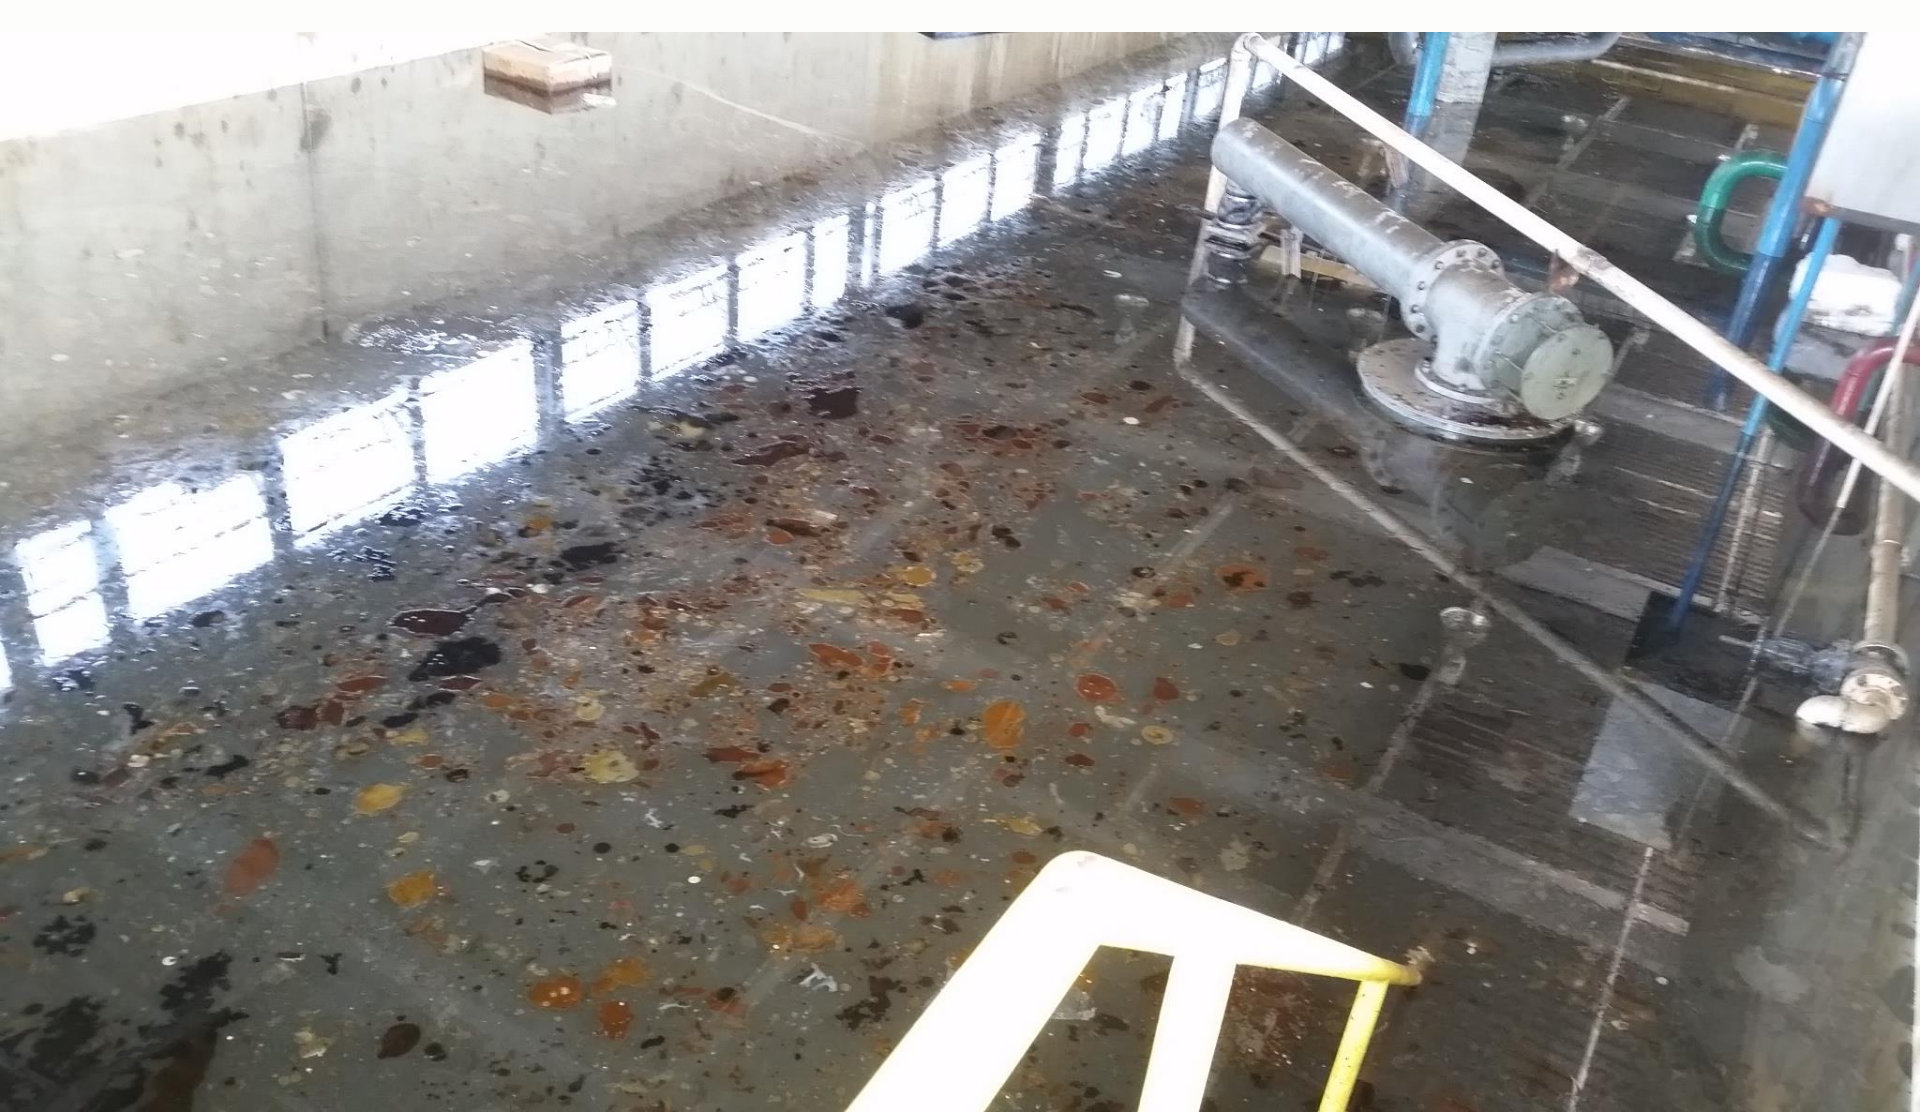
Water is denser than oil, so all lubricants and fuels were displaced to the surface of the flood. Machines had to be torn down to the bearings and reassembled before use. The water in this image is 17ft above the ground.

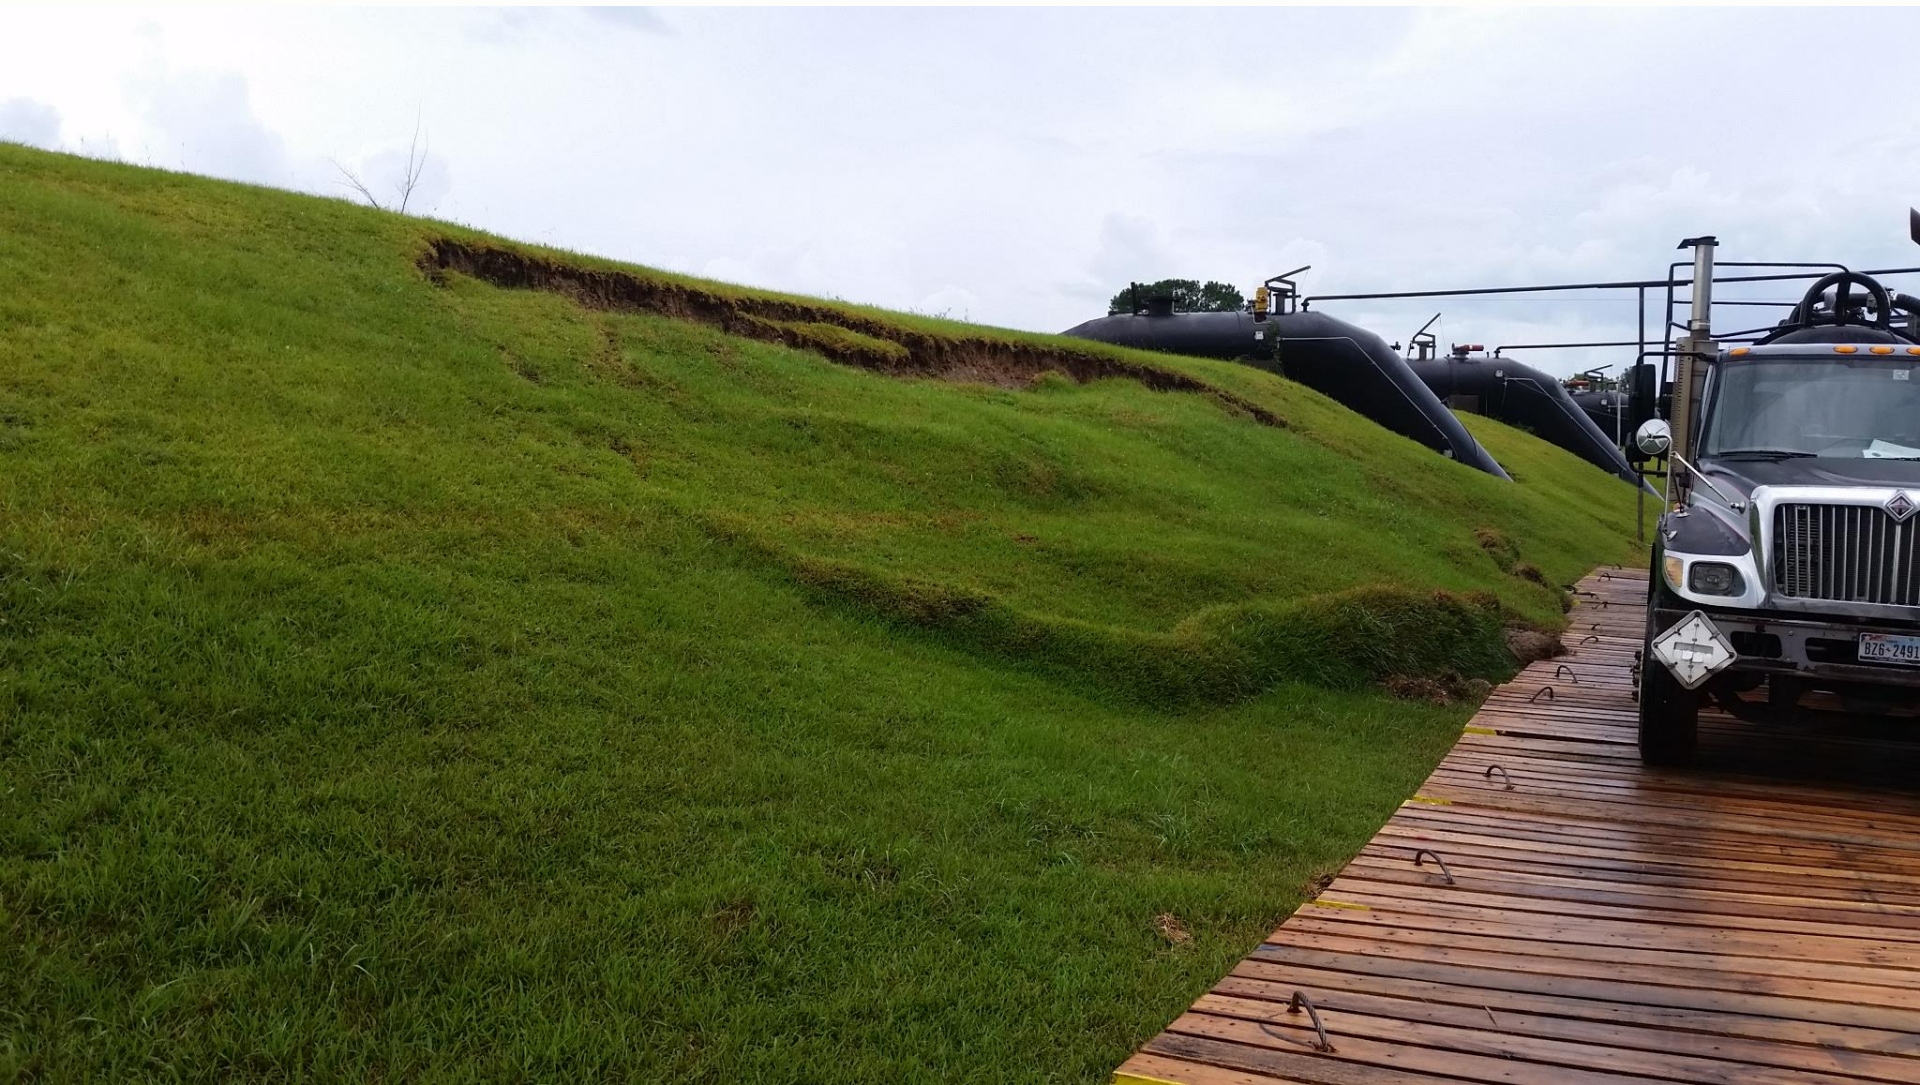
Levees and overpasses sloughed due to flooding, contributing to damage.

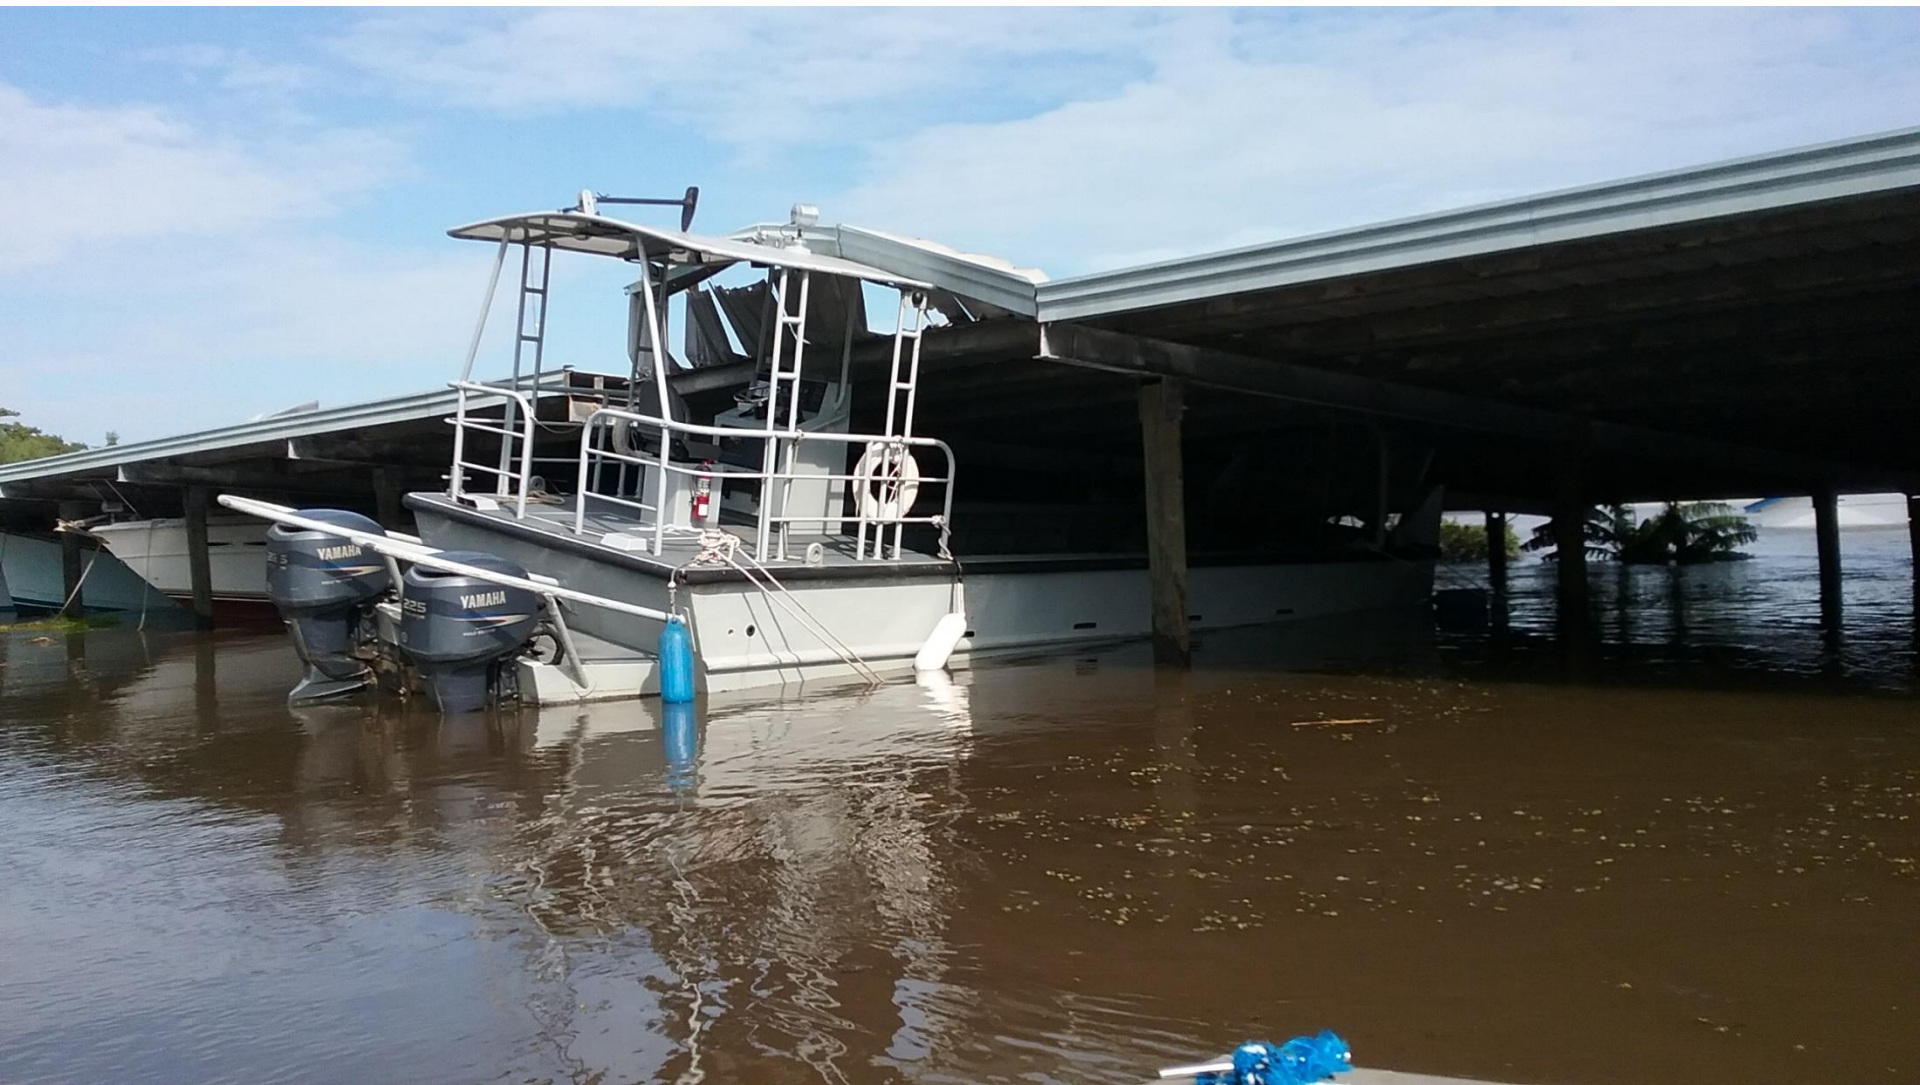
The marina was hit hard, with some boats damaging the marina – and other boats damaged by the marina.

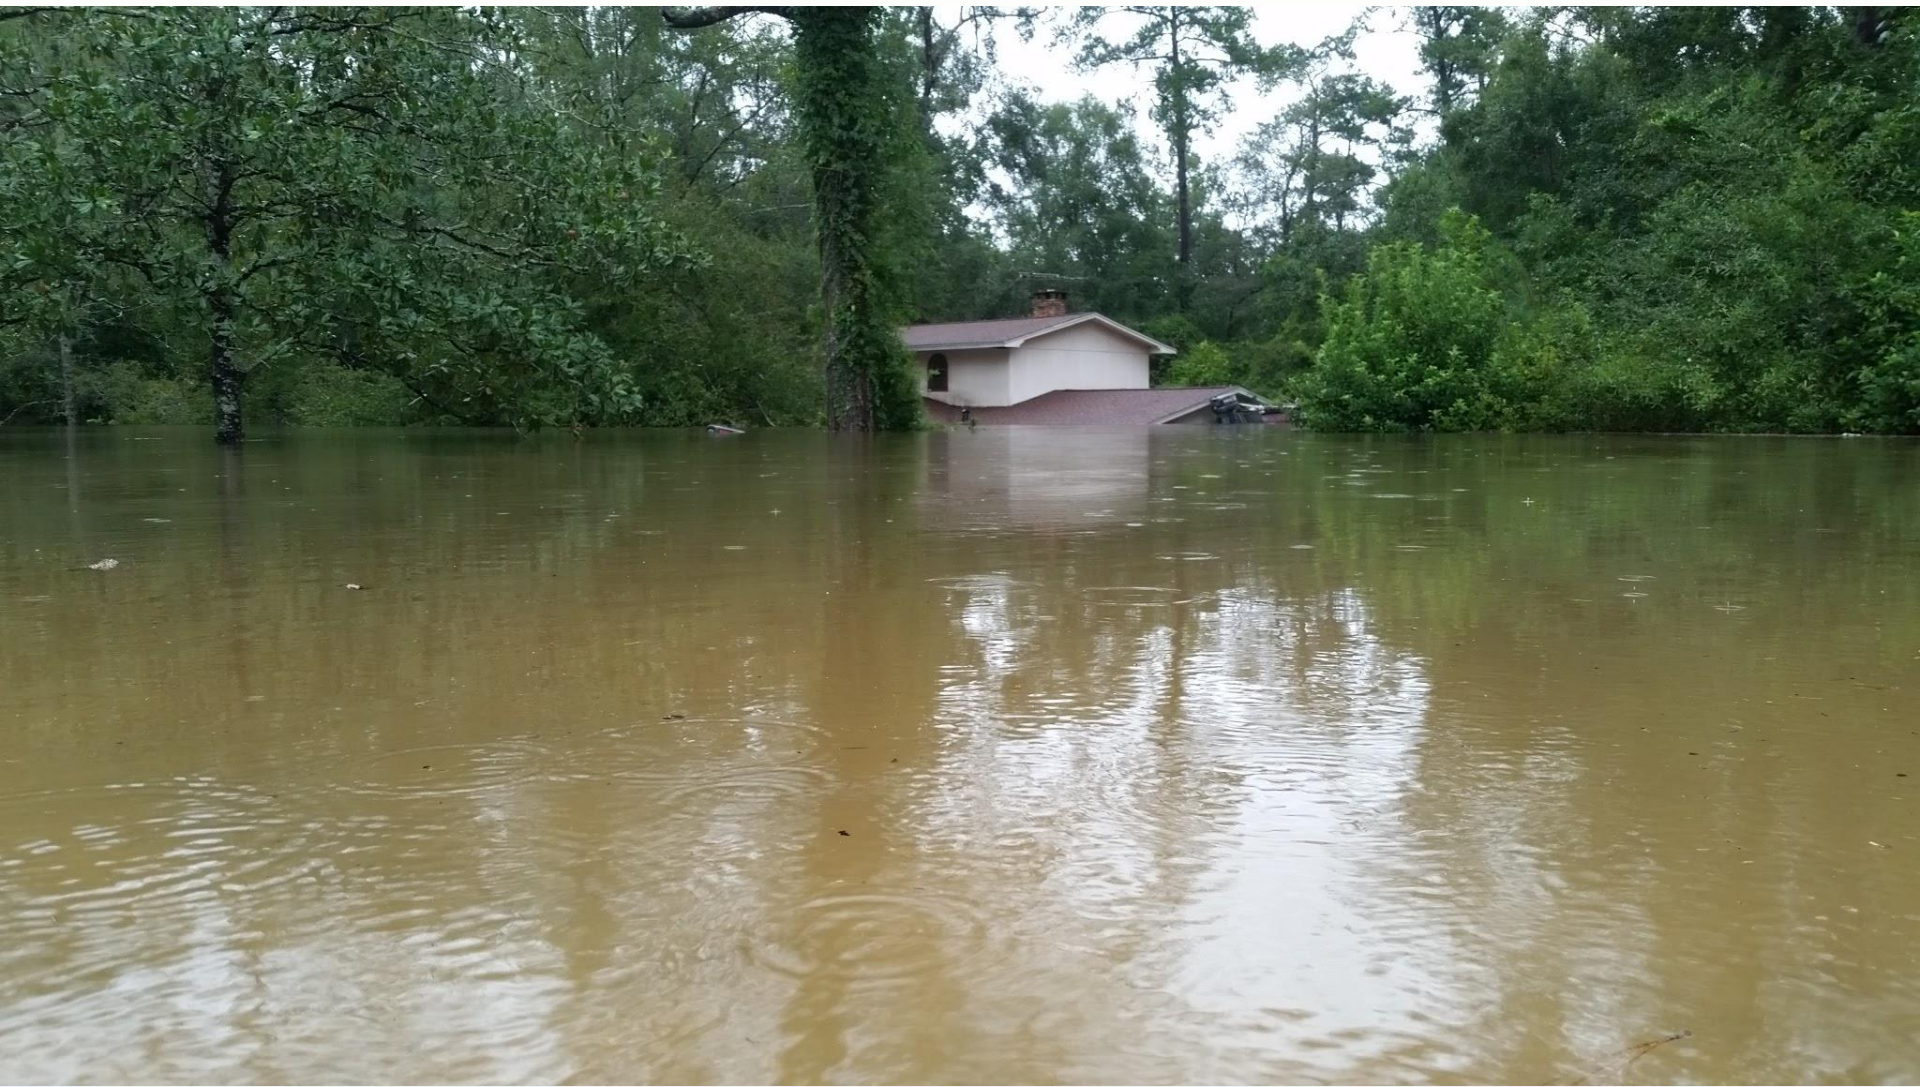
Village Creek near Lumberton, TX. The nearest bridge physically washed out in places.

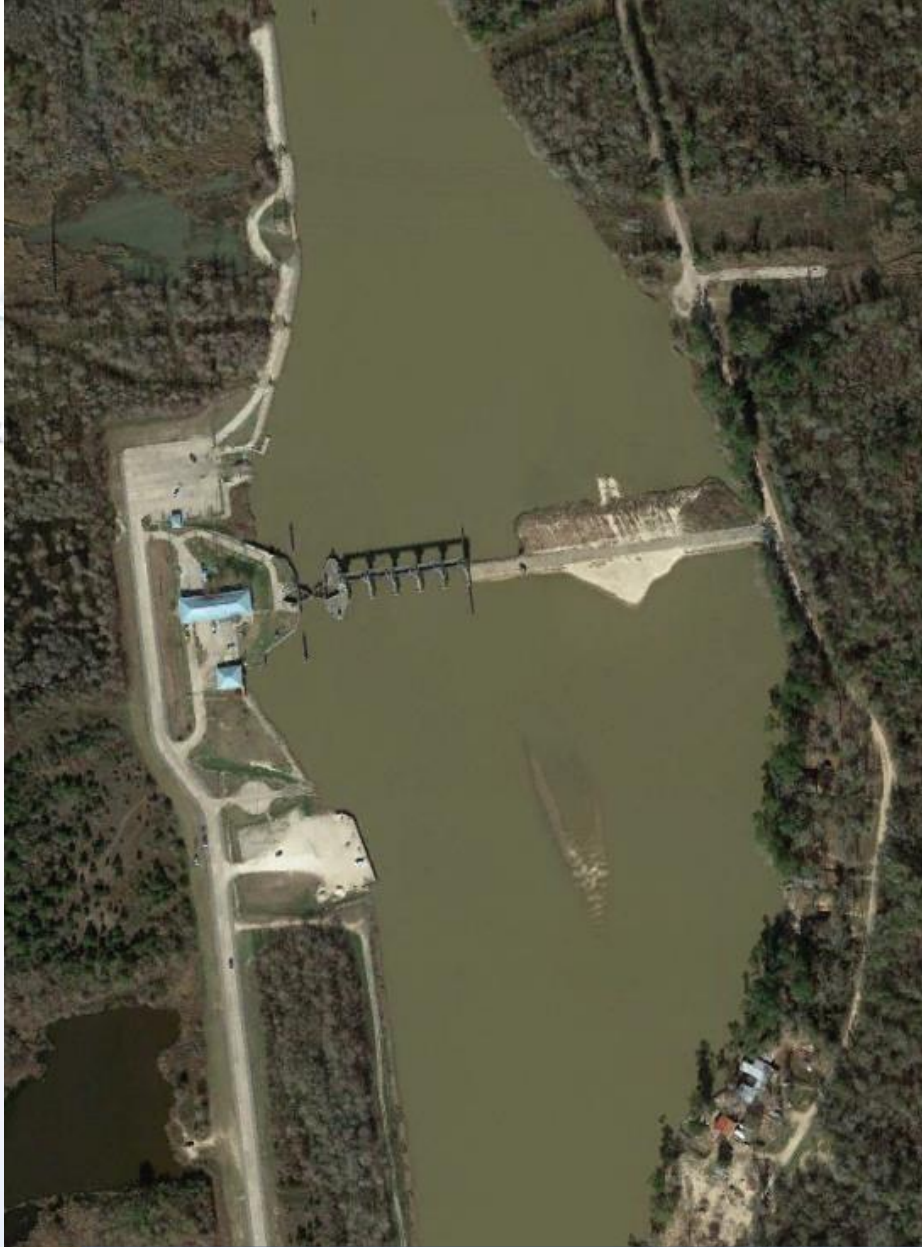
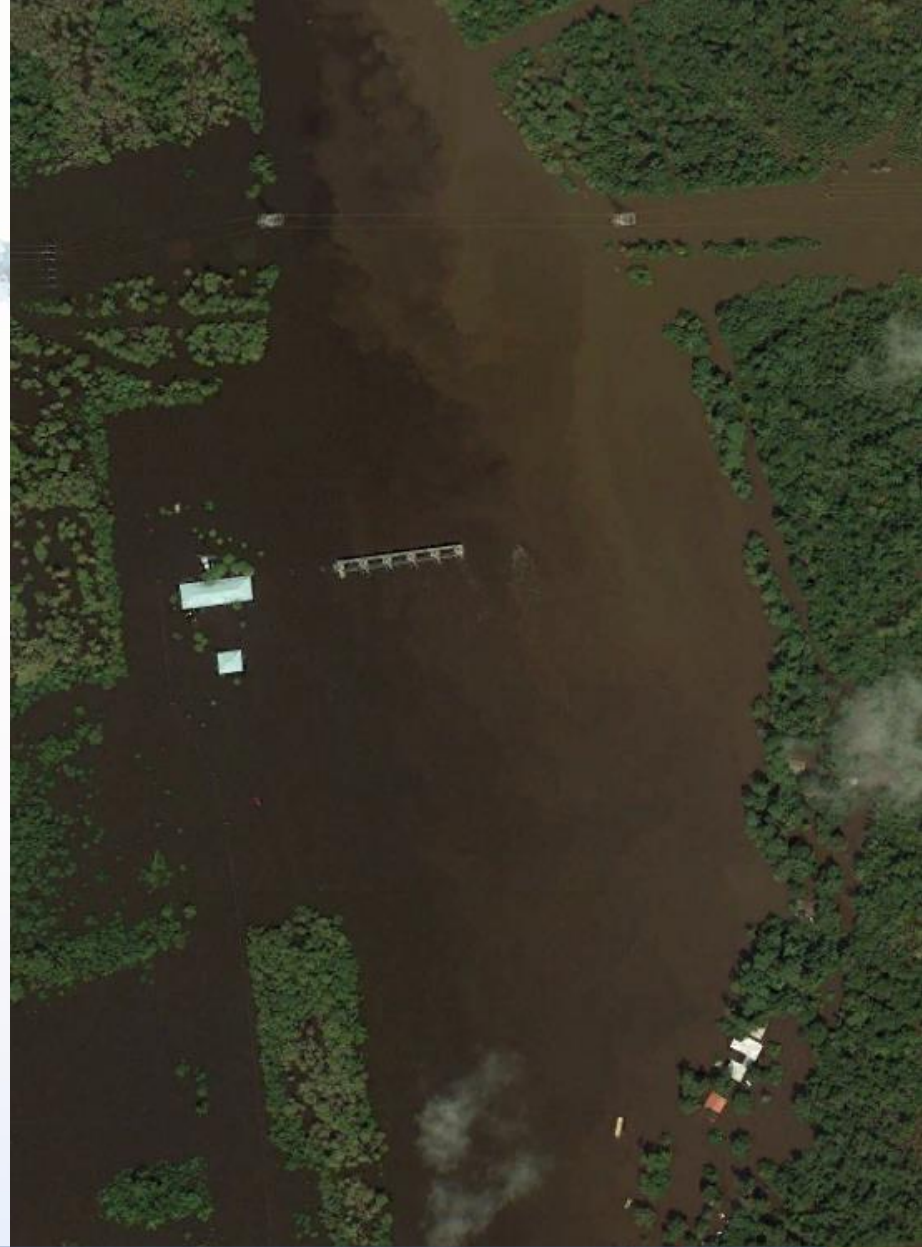
Image at Left is the most recent image of the barrier. Image at right is the LNVA saltwater barrier during Hurricane Harvey.

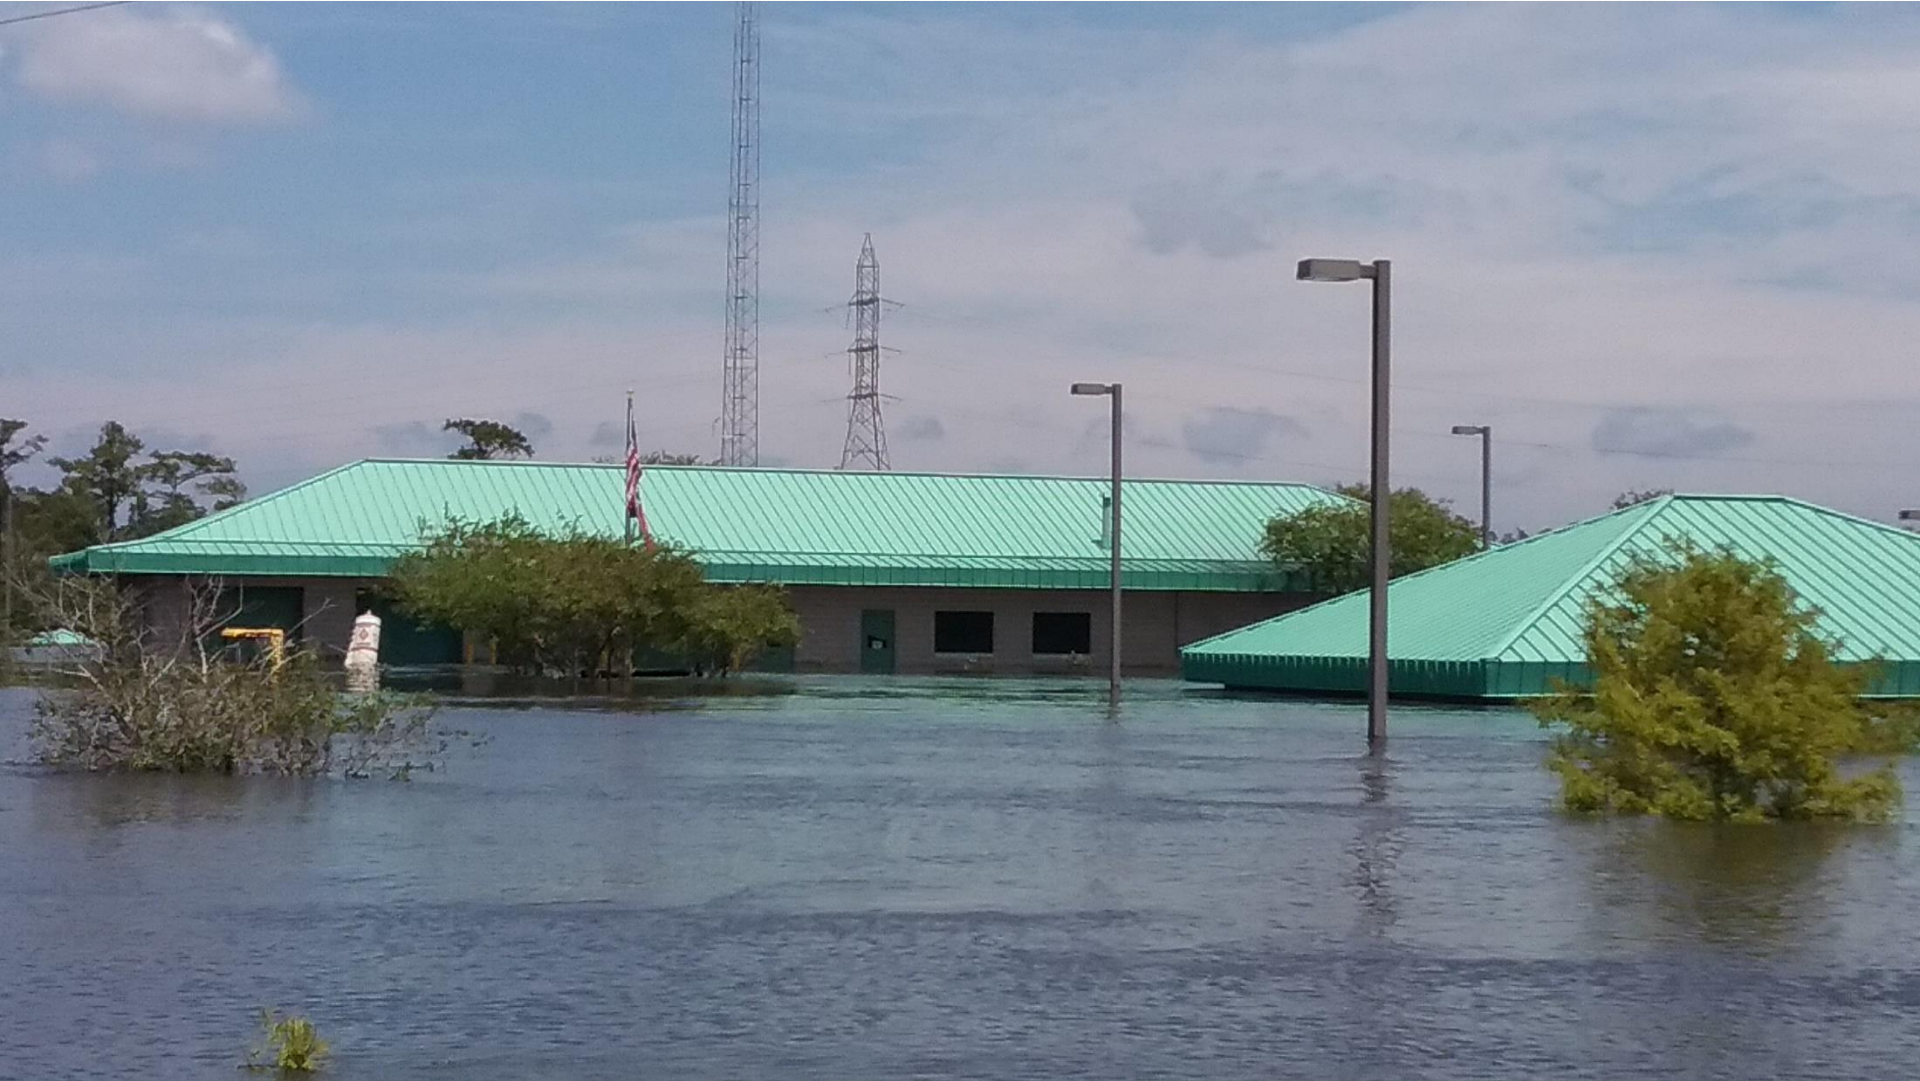
This image was taken after the storm had passed and the flood waters had begun to recede.

Harvey Line: >21ft

Gage Board: 2'8"

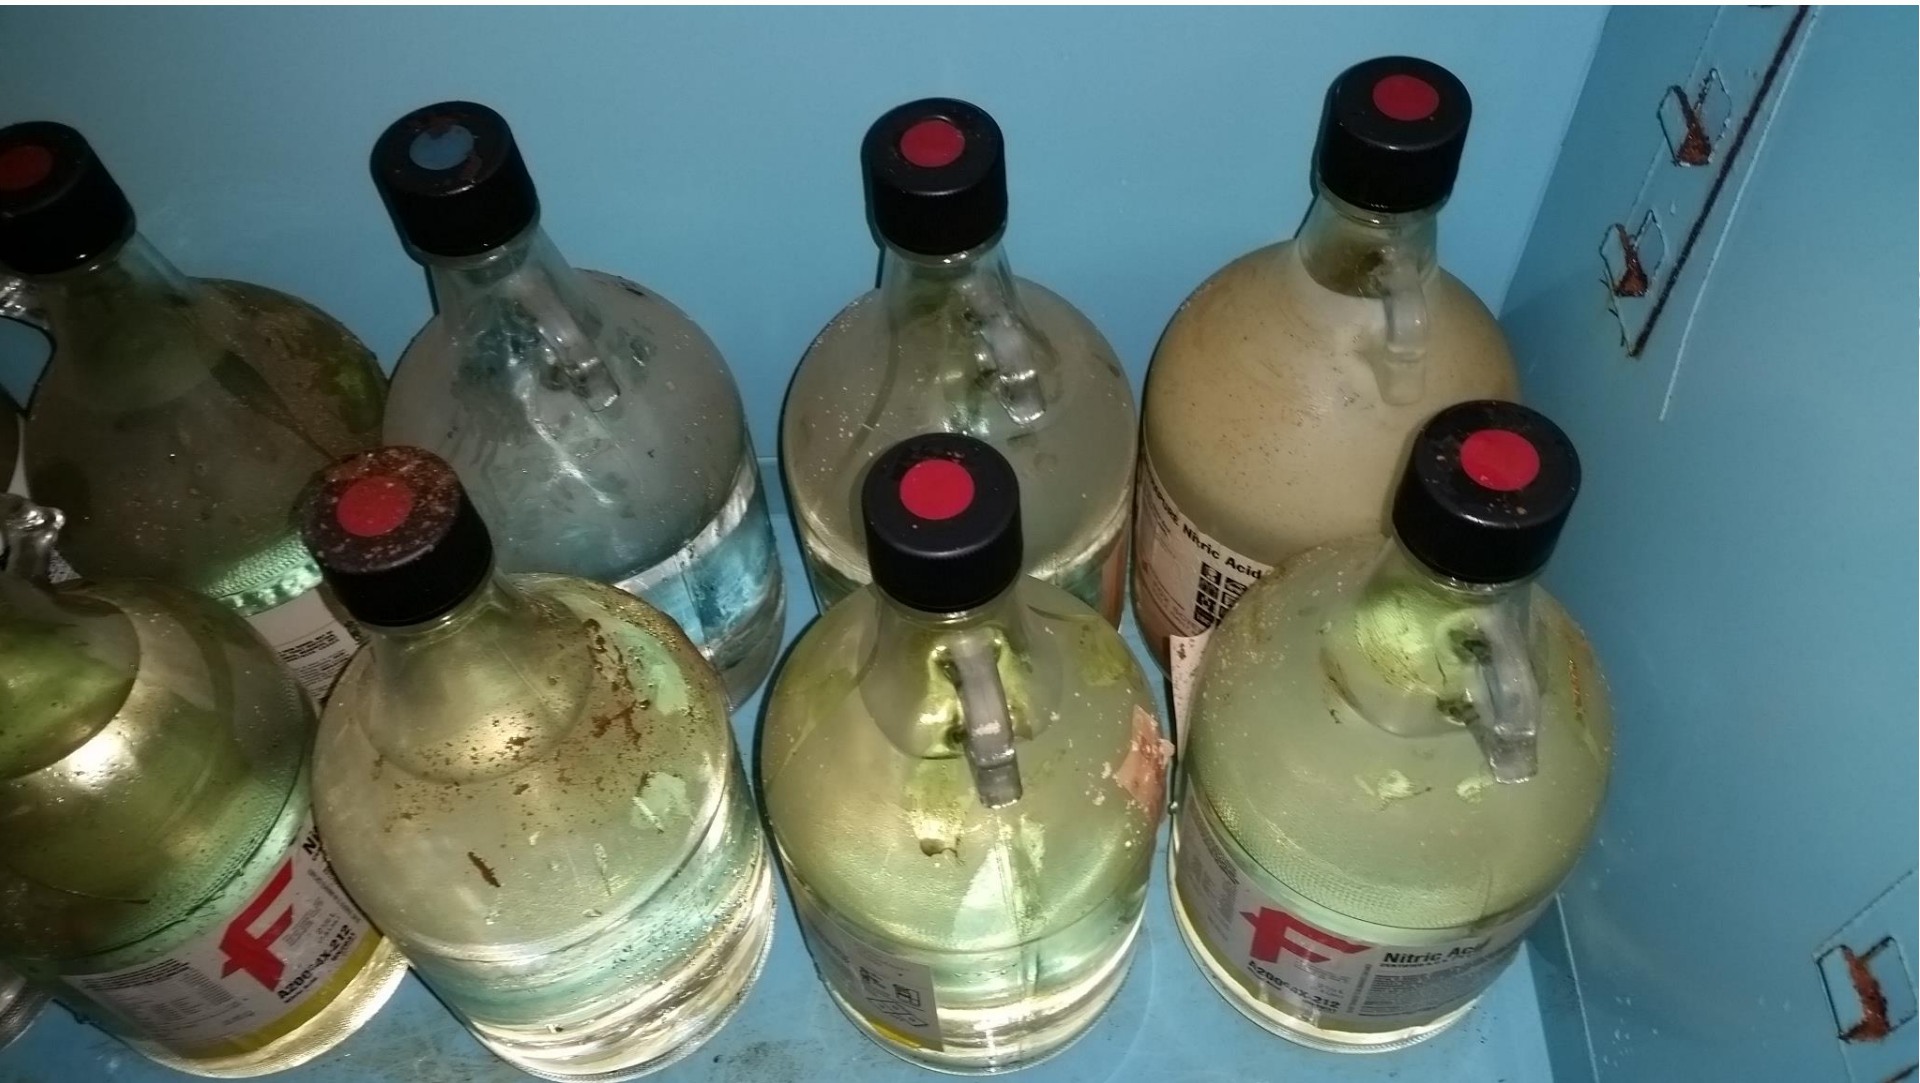
Entering the lab post-Harvey was done with a bit of trepidation.
Some of these are acids with a pH less than zero.

- Consider mobility of equipment
 - Setting high-value instruments higher would have saved them
 - Evacuating portable readers (such as Hach devices) would have been easy
- ***Really*** plan for the worst
 - Assume facility will be *gone* -- and all paper copies with it
 - Have inventories in digital form, off site, and backed up regularly
 - Take pictures of every piece of equipment, before *and* after
 - i.e. have regular inventory updates, pictures, S/Ns, order #'s, etc

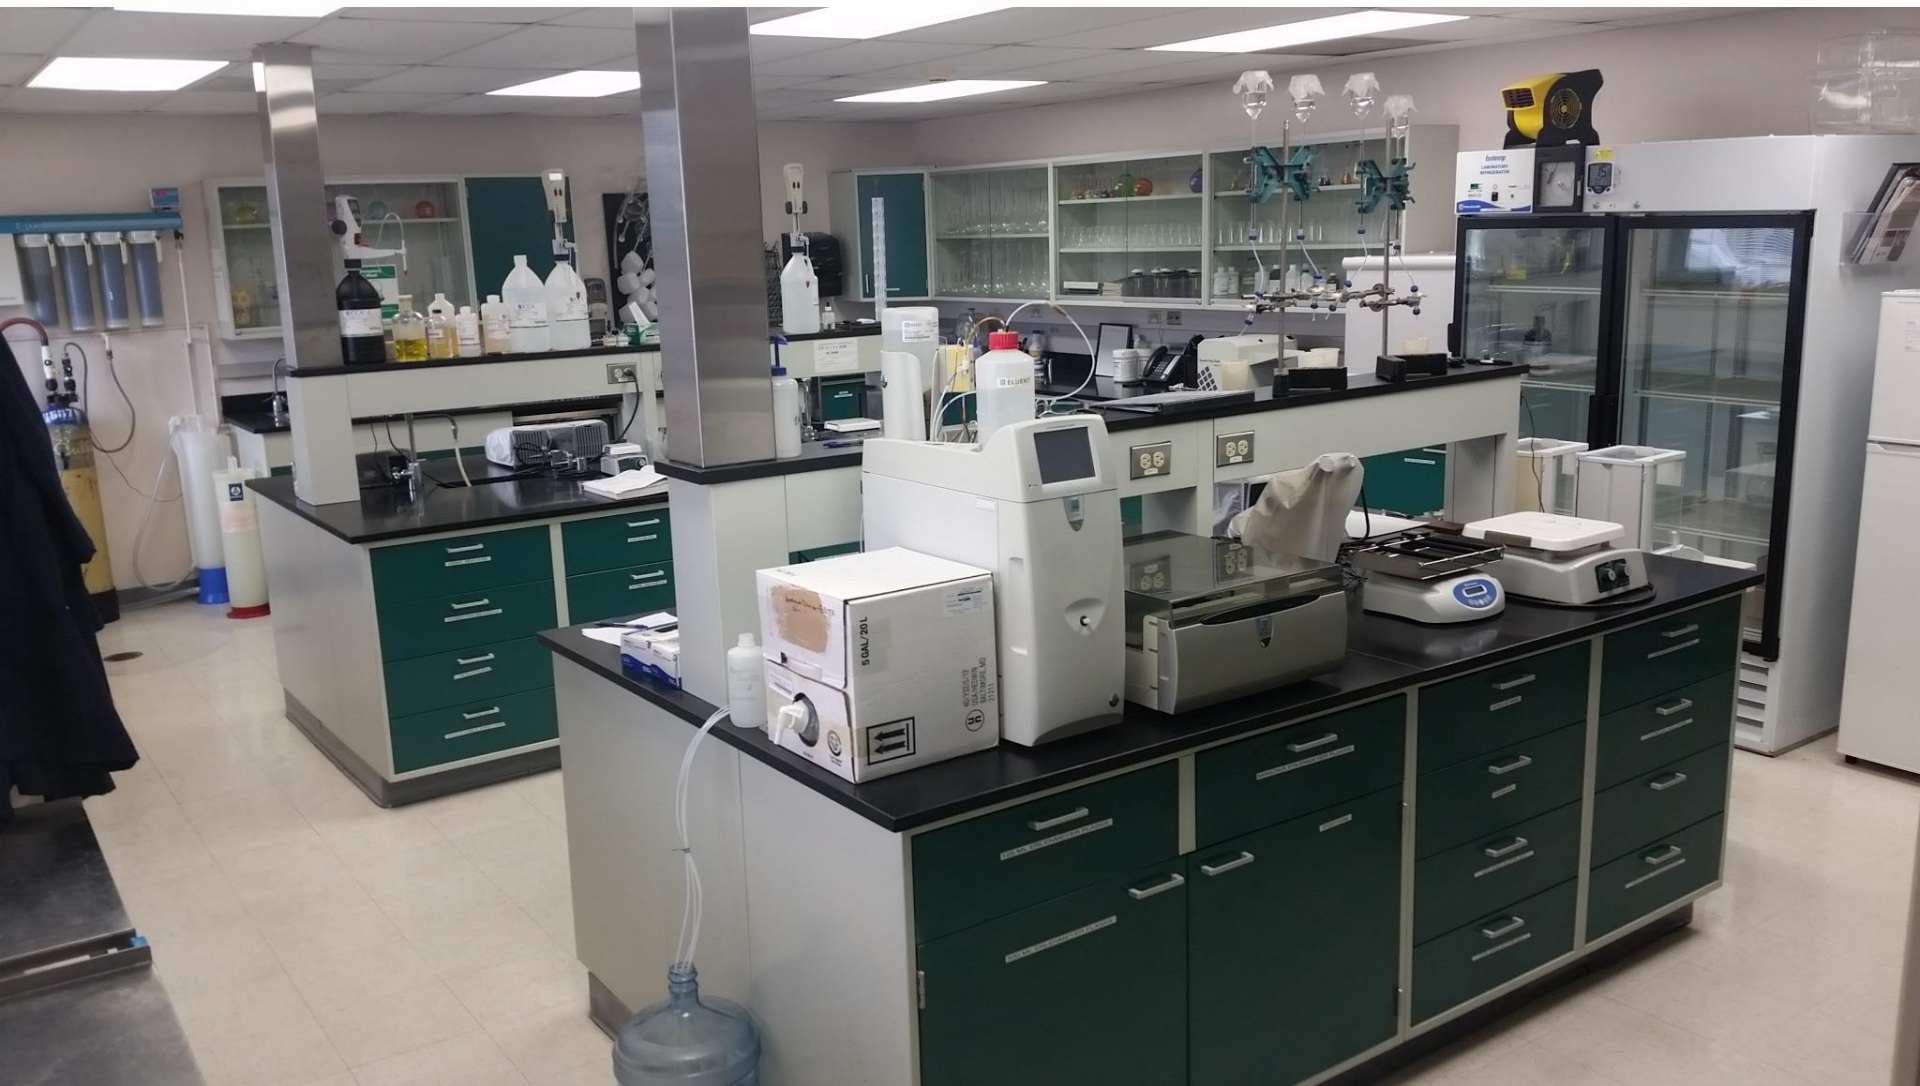
LNVA SWB lab before Hurricane Harvey

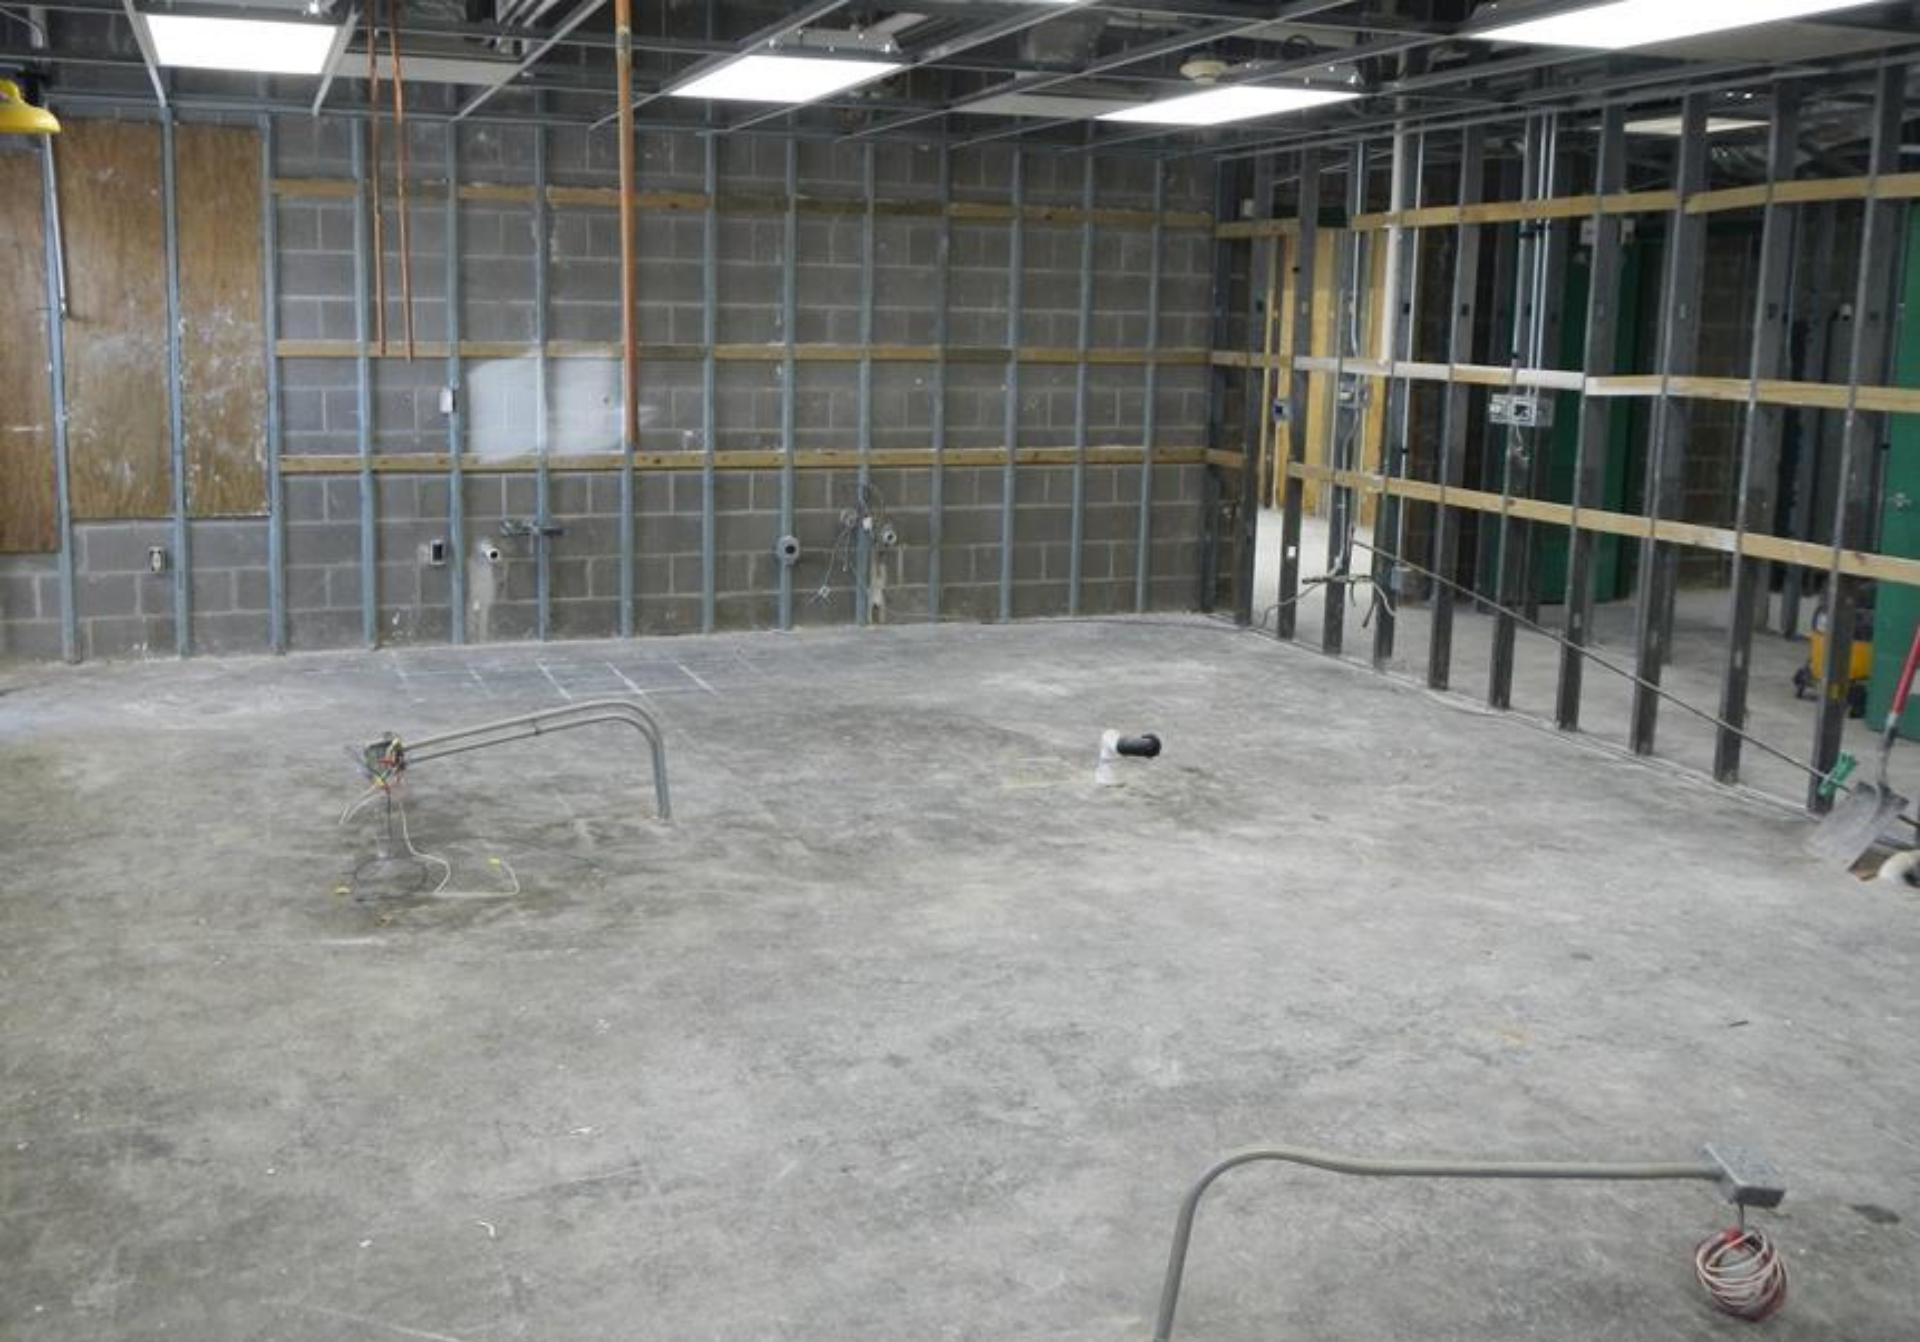
LNVA SWB Lab after Hurricane Harvey (late September 2017)

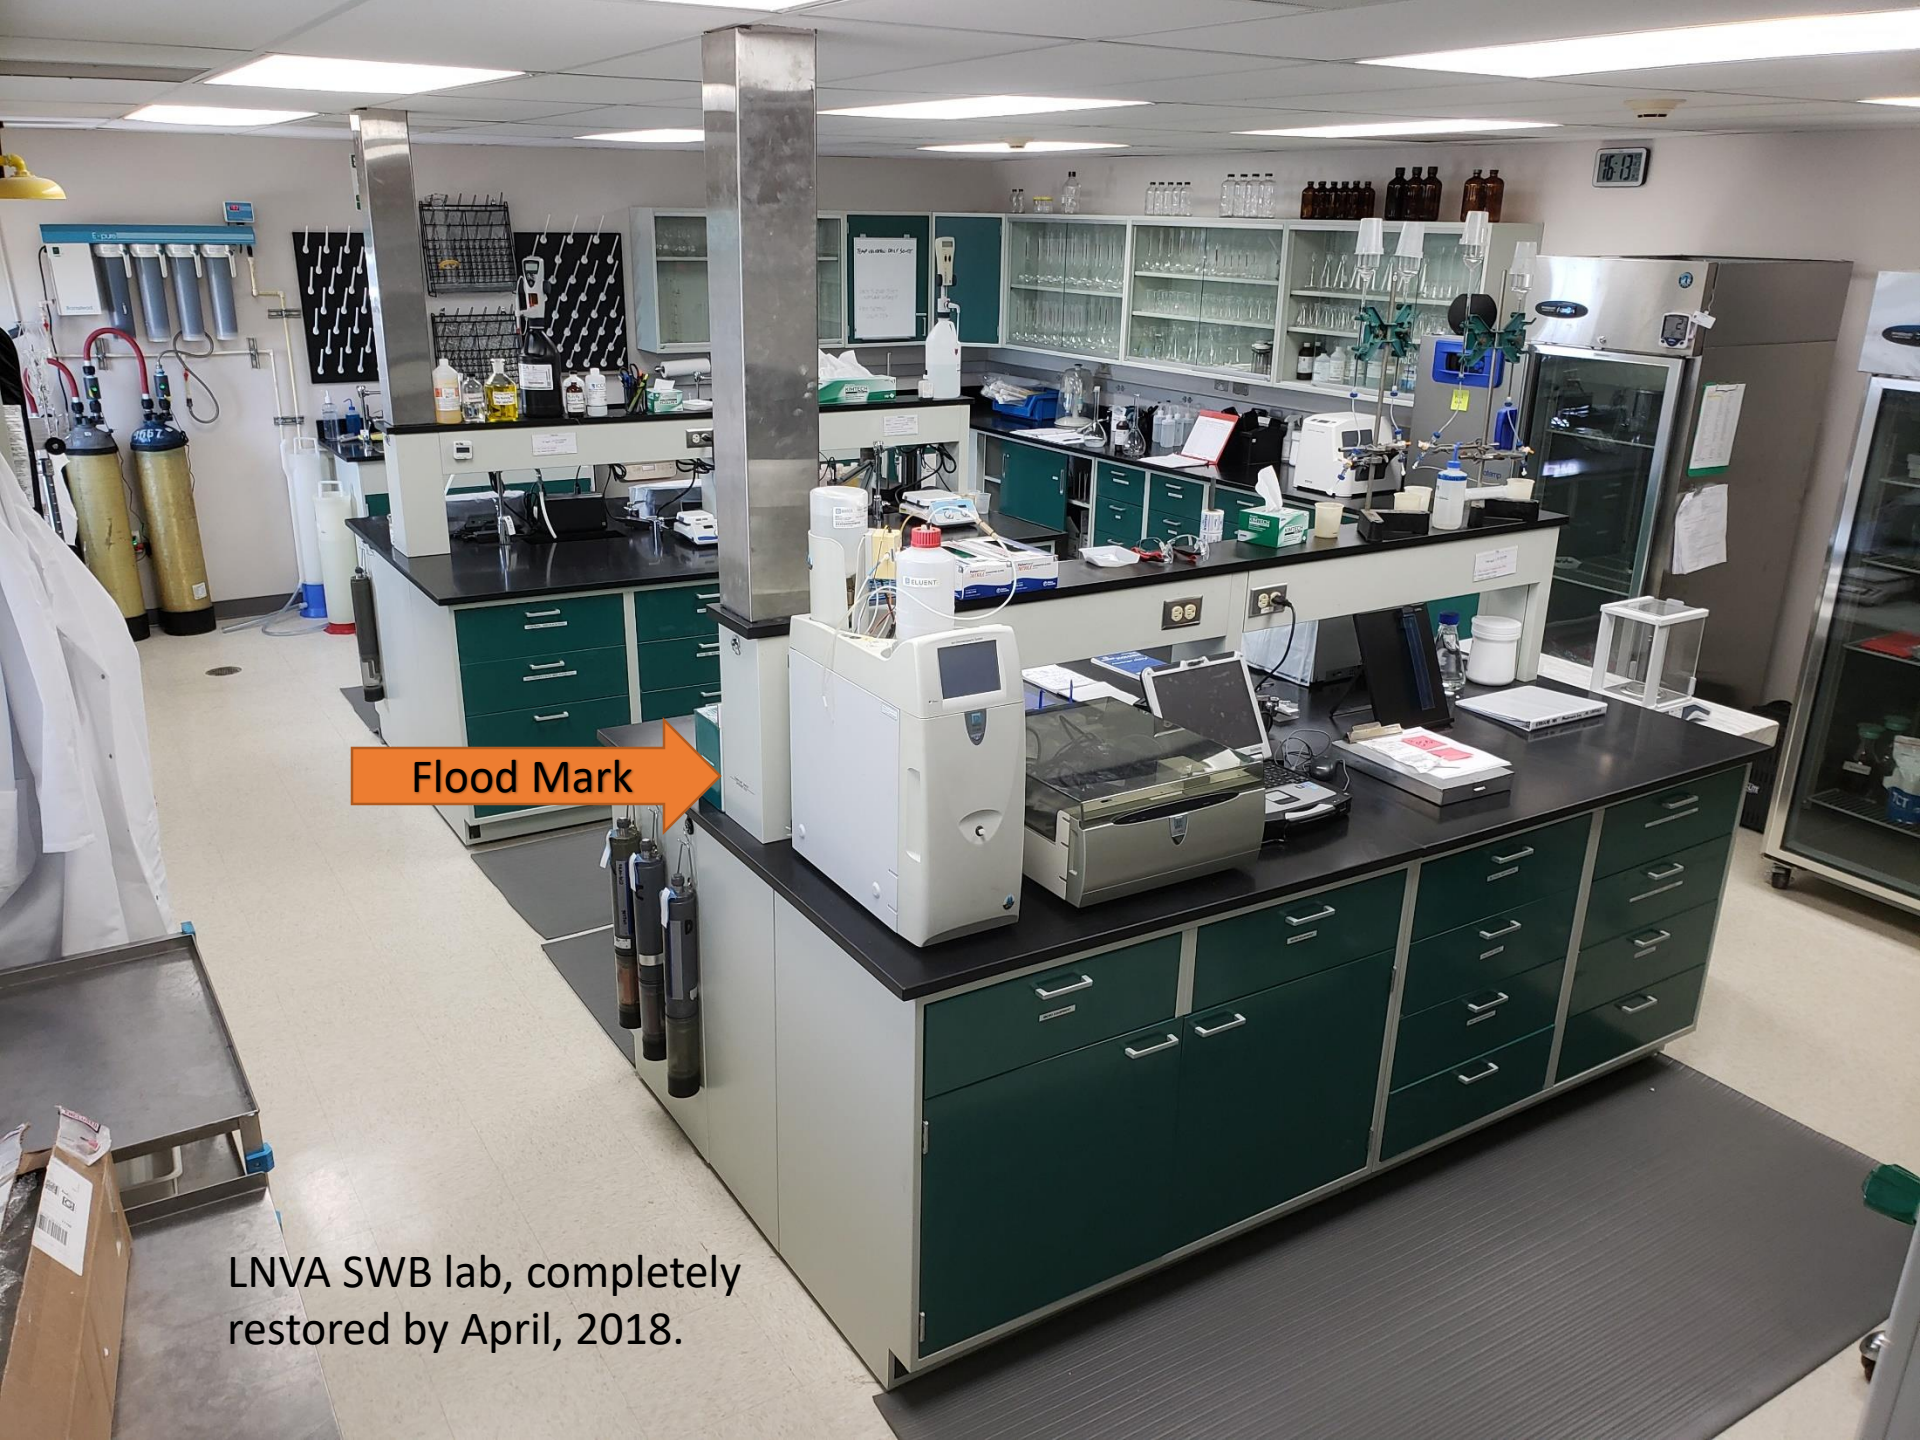
Flood Mark

LNVA SWB lab, completely
restored by April, 2018.
